CONFIDENTIAL REPORT OF CONDITION AND VALUATION SURVEY for purposes of insurance evaluation

Survey #08/17-XXXX
40' Tollycraft
Survey performed for XXXX, owner,
with the vessel afloat,
on 8/30/2017

Vessel Type: 1971 40' Tollycraft Royal Tri-cabin
Hull ID number: 409612
Hull ID number verification attached: The hull ID number was not found at the starboard aft corner of the transom but was taken from the registration -- *strongly recommend inscribing the hull ID number into the starboard aft corner of the transom for identification purposes.*

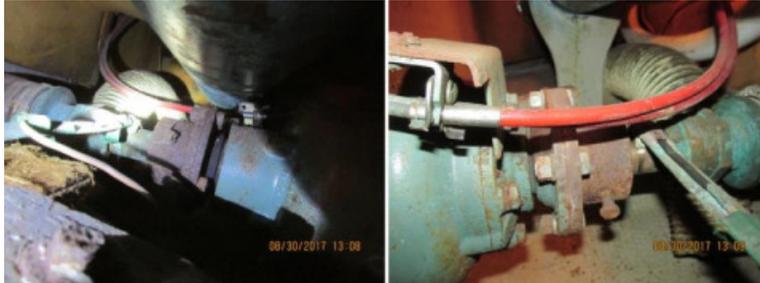
Coupler(s): Couplers slightly rusty -- *recommend de-rusting.*

Couplers slightly rusty -- *recommend de-rusting.*

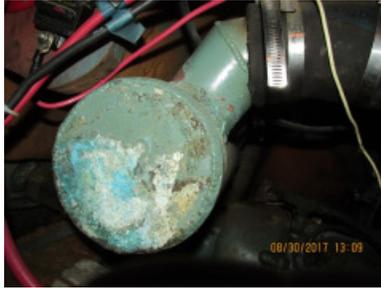
Inboard end of port exhaust system collector corroded -- correct, as required.

Inboard end of port exhaust system collector corroded -- *correct, as required.*

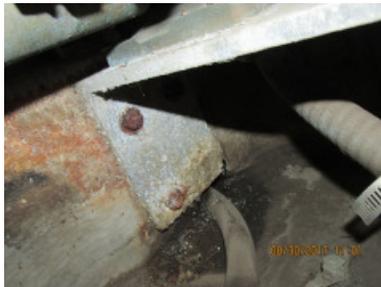
The bracket that supports the hydraulic cylinder in the cockpit bilge is corroding on the piece that bolts to the stringer -- *de-corrode*.

The bracket that supports the hydraulic cylinder in the cockpit bilge is corroding on the piece that bolts to the stringer -- *de-corrode.*

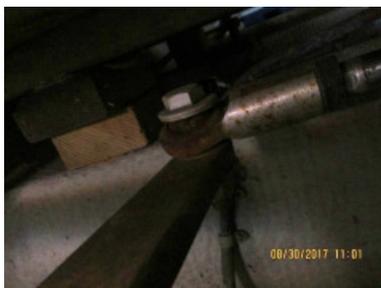
The portion that connects to the steering arm for the starboard rudder is slightly rusty -- *de-corrode*.

The portion that connects to the steering arm for the starboard rudder is slightly rusty -- *de-corrode.*

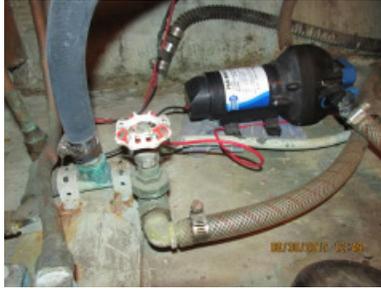
Number of tanks: Unknown
Capacity: 150 USG (reportedly)
Shut off valve(s): Unknown -- *recommend ensuring existence and operational status if already in place; provide if no shut off(s) installed.*
Filling line(s) located: Side deck
Tank(s) vented: Yes
Vent(s) location(s): Hull side
Tank(s) material: Not sighted
Tank(s) secured: Not sighted
Tank(s) location(s): Not sighted
Inspection/cleaning access: Not sighted -- *recommend providing easy access to tank and connections for inspection purposes.*
Tank(s) condition: Not sighted
Water pump(s): 12V
NOTE: Gate valves in the plumbing systems in the aft cabin and in the forward engine bilge are frozen -- *correct, as required.*

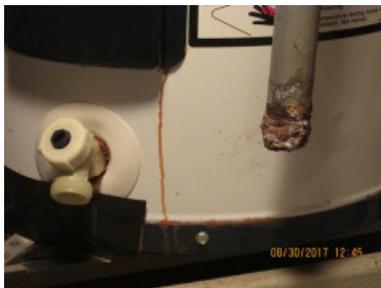
Number of heaters: One
 Manufactured by: Whirlpool
 Capacity: 12 USG
 How powered: 110V
 Supply lines: Copper
 Tank(s) secured: Yes
 Tank(s) location(s): Forward engine space
 Inspection/cleaning access: Good
 Tank(s) condition: Evidence of some tank leakage noted -- *investigate and repair, remove from service or replace, as/if required.*

Evidence of some tank leakage noted -- *investigate and repair, remove from service or replace, as/if required.*

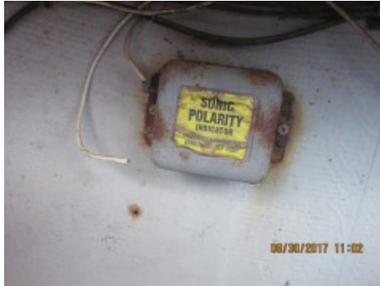
Shore power inlet(s): One Marincos 30 AMP
Shore power cord(s): One 30 AMP
Main breaker(s): A main breaker has been installed; however, it is not within 10 feet of the shore power inlet -- relocate to within 10 feet OR provide additional fuses or circuit breakers within 10 feet of the inlet (per ABYC E-11.10.2.8.3).
Distribution panel(s): Yes -- a breaker box is installed -- ensure that the current rating of each breaker does not exceed the maximum current carrying capacity of the conductor being protected.
Reverse polarity indicator(s): Yes -- sonic polarity indicator -- one of the wires to the indicator is disconnected -- correct, as required.
