CONFIDENTIAL REPORT OF CONDITION AND VALUATION SURVEY for purposes of pre-purchase evaluation

Survey #08/17-XXXX

Survey performed for Mr. XXXX, purchaser,
with the vessel hauled out,
on 8/18/2017

Vessel Type: 1974 47' Boatel houseboat
Vessel Name: "Lady Clarice"
Hull ID number: BTL017780674
Hull ID number verification attached: A true digital photograph of the hull ID number of the referenced vessel is incorporated herein.

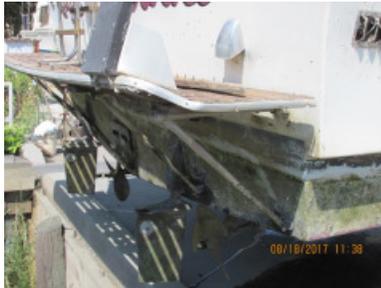
Construction material: Fiberglass
Stem: Flared
Rub rail: Aluminum trim -- some prior impact damage noted in way of the starboard forward corner -- seller reports this has been present for many years.
Transom: Slightly flared with teak swim grid bolted on -- the starboard corner of the swim grid was run into by a third party -- see comments under Canvas in the Main Deck section.

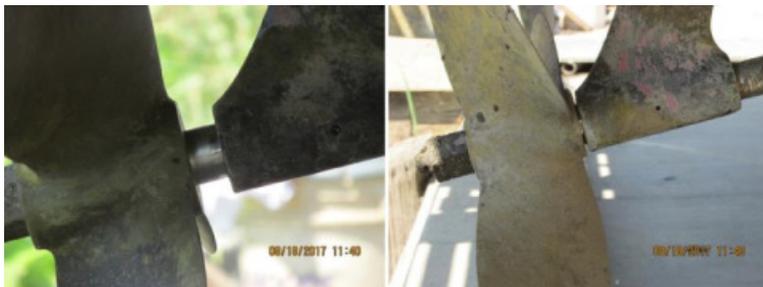
Number of propellers: Two
 Manufacturer: Michigan Dyna-Jet
 Number and type of blades: Three fixed each
 Material: Bronze
 Pitch and diameter: 19 X 18 (as stamped)
 Age: P - 1999, S - 1974
 Prop nuts: The thinnest of the two propeller nuts has been placed last (furthest away from the propellers) on both shafts, which is incorrect -- *place the thinnest propeller nut closest to each propeller (per ABYC P-6, Ap.6.2).*
 Condition: One blade tip of port propeller is out of true -- *have propeller trued, pitched and balanced.*
 The starboard propeller is original -- *recommend having it trued, pitched and balanced, as well.*
 NOTE: Port propeller and starboard propeller have different distances from the aft ends of the struts -- *investigate and correct, as required.*

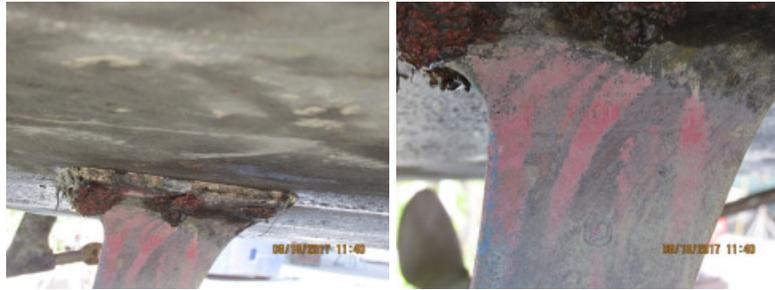
Number of shafts: Two
 Size: 1-1/4"
 Material: Stainless steel
 Cutless (shaft) bearing(s): Serviceable
 Strut(s): Bronze -- rusting noted in way of bolts -- *remove the bolts, clean up (or replace) and re-bed.*
 Surface discoloration noted on the struts and the rudders -- this generally occurs due to

stray current -- see Zincs Note.

NOTE: Discoloration (surface) noted to the bronze rudders and bronze struts -- *have the bonding and zinc systems evaluated by a qualified corrosion expert.*

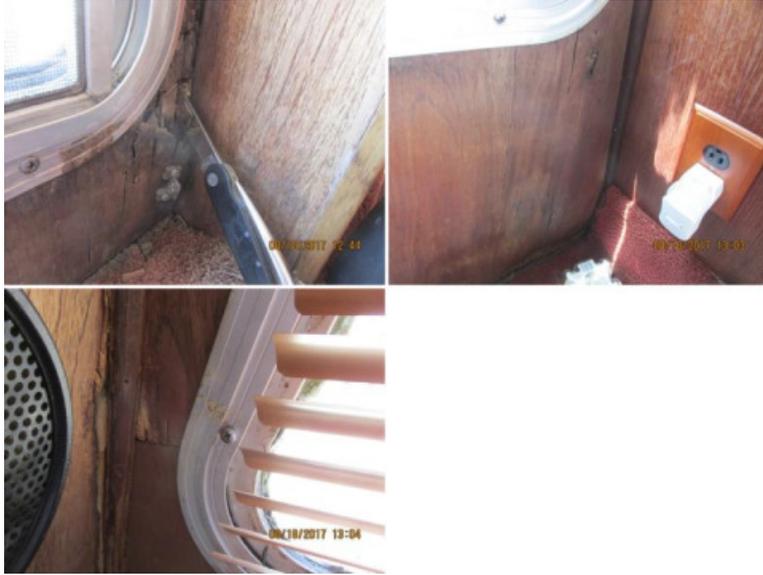
Fair to good -- there is water staining in the paneling at the carpet level -- see Window leakage comments.

Significant leakage and deteriorated wood noted around the aft windows and the aft ends of the aft side windows -- *carve to sound and replace the woodwork, as required, and re-seal the windows, as required.*

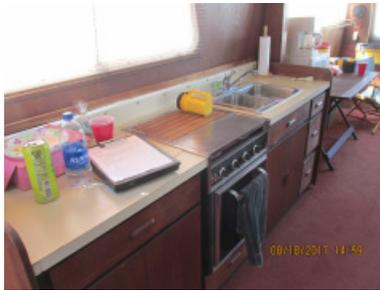
Princess three burner electric with oven -- one of the burners is not operational -- *correct, as required.*

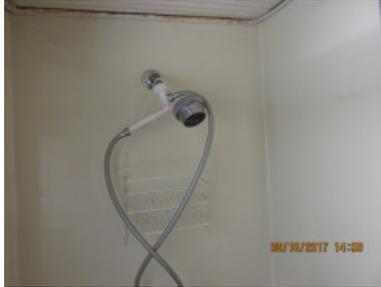
Handheld in stall in the midships head -- unable to get the shower to operate -- *investigate and correct, if/as required.*

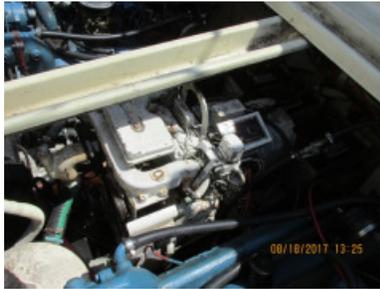
Year: Original
 Manufacturer: Onan
 Serial number(s): Tag illegible
 Model number(s): Tag illegible
 Hour meter: None sighted -- *recommend installation of hour meter to facilitate the tracking of routine maintenance.*
 Location(s): Aft bilge/engine space
 Type of installation: On tray
 Fuel type: Gas
 Kilowatt rating: 8.5 KW
 Drip pan(s) beneath motor(s): Yes
 Cooling system(s): Heat exchanger
 Exhaust discharge location: Transom
 Exhaust piping: Hose -- showing signs of age -- *will require replacement in the foreseeable future.*
 Exhaust hose connections double clamped: No -- *double clamping required (where practical).*
 Muffler(s): Onan Aqualift
 Ventilation: Natural and blower
 Accessibility: Good
 Last major overhaul: Unknown
 Generator set(s) operated: Not operated for purposes of this survey.
 Mechanical survey performed: Yes -- unit reportedly difficult to start -- *correct any deficiencies found by engine surveyor.*
