R J Whitfield & Associates, Inc.

CONFIDENTIAL REPORT OF CONDITION AND VALUATION SURVEY for purposes of pre-purchase evaluation

Survey #10/16-XXXX
C & C 110
Survey performed for XXXX, purchaser,
with the vessel hauled out,
on 10/21/16

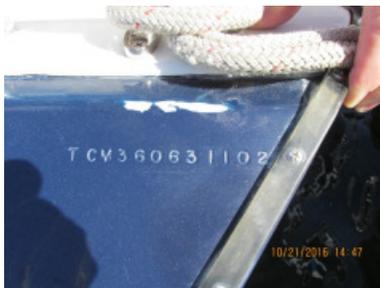
Vessel Type: 2002 C & C 110 auxiliary sloop
Vessel Name: "Wicked Fun"
Hull ID number: TCM360631102
Hull ID number verification attached: A true digital photograph of the hull ID number of the referenced vessel is incorporated herein.

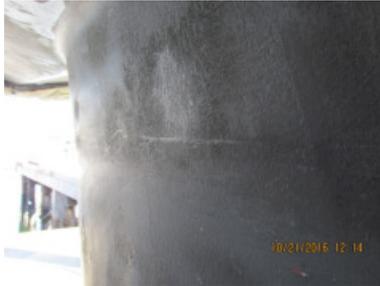
Construction material: Fiberglass
Keel(s): Lead ballast keel bolted on -- minor separation noted -- *monitor and correct if condition worsens.*

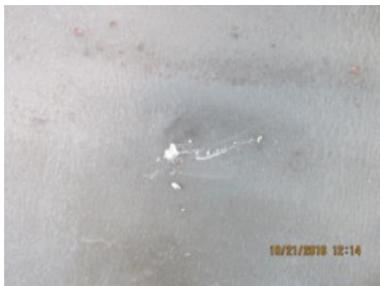
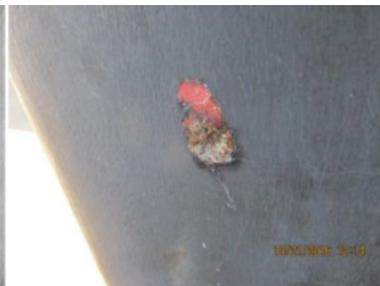
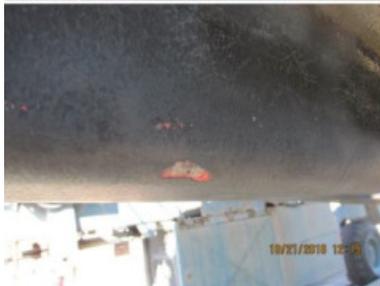
Bottom paint: Minor areas of flaking bottom paint noted, mostly on the keel, that require attention prior to renewal of bottom paint -- *sand keel and spot sand other areas of the hull prior to renewal of the anti-fouling bottom paint.*

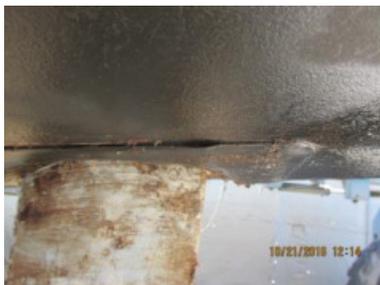
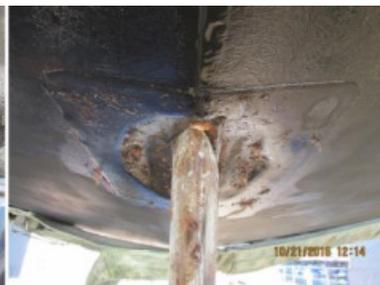
NOTE: The seal around the perimeter of the sail drive has lifted up in one spot and fits differently on one side of the drive compared to the other, although no internal leakage noted -- *correct, as required.*

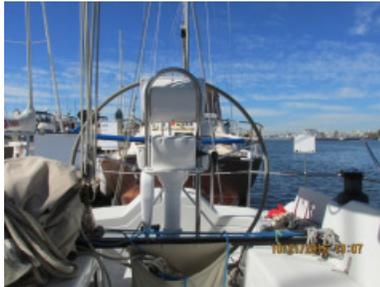
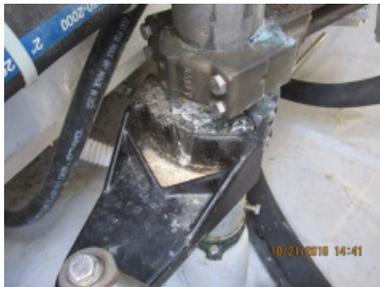
Steering station location(s): Cockpit
Type: Wheel -- rim has been wrapped with rawhide.
Manufacturer: Whitlock
Mounting(s): Quadrant at the top of the rudder stock -- possible corrosion noted at the quadrant -- *investigate and correct as/if required.*

Rudder stock(s): Visually sound
Wheel brake(s): Yes -- unit does not hold the wheel when tightened -- *recommend adjustment.*
Emergency tiller: Yes
Autopilot: Raytheon ST5000+

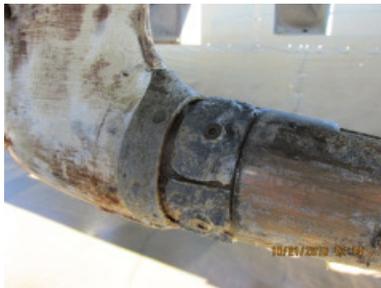
Sail drive(s): Yes
 Replacement required?: One zinc is wasted and the other has useful life remaining -- *replace the wasted zinc.*

Condition: One zinc is materially wasted away -- *strongly recommend having a corrosion survey performed if the vessel is kept in her current location.*
