CONFIDENTIAL REPORT OF CONDITION AND VALUATION SURVEY for purposes of pre-purchase evaluation

Survey #08/17-XXXX

Survey performed for Mr. XXXX, purchaser,
with the vessel hauled out,
on 8/18/2017

Vessel Type: 1974 47' Boatel houseboat
Vessel Name: "Lady Clarice"
Hull ID number: BTL017780674
Hull ID number verification attached: A true digital photograph of the hull ID number of the referenced vessel is incorporated herein.

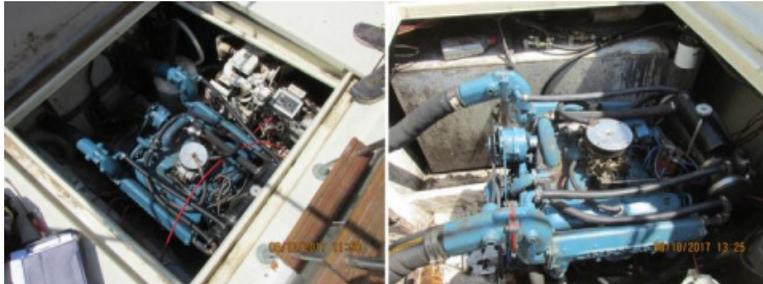
MAIN ENGINE(S):

Type: Inboard with V-drives
Manufactured by: Chrysler
Serial number(s): Not sighted
Model number(s): 350 (reportedly)
Naturally aspirated? Yes
Horsepower: 250 HP each
Number of cylinders: Eight each
Year: Original
Engine(s) location(s): Aft bilge
Engine space hatch(es): In aft deck
Fuel type: Gas
Fuel pump(s): Engine mounted
Fuel filter(s)/water separator(s): Sierra 18-7945
Hoses and clamps: Serviceable
Belts and pulleys: Good
Engine mounts and beds: Good
Throttle and shift control(s): Separate levers for each engine at both steering stations -- flybridge shift controls stiff-- *recommend servicing/lubrication at both ends.*

Separate levers for each engine at both steering stations -- flybridge shift controls stiff-- *recommend servicing/lubrication at both ends.*

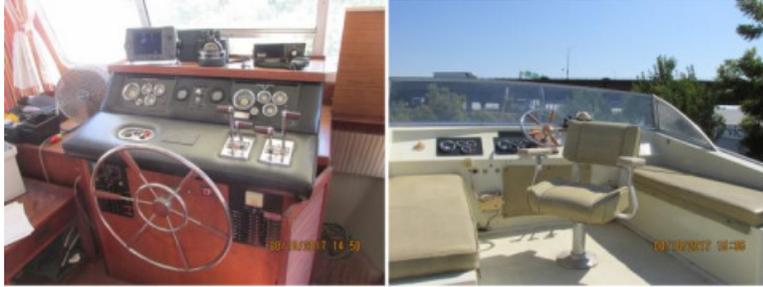
STEERING SYSTEM(S):

Steering station location(s): Main saloon and flybridge
 Type: Hydraulic
 Manufacturer: Teleflex
 Lines and fittings: Hose
 Actuator cylinder(s): Visually sound
 Mounting(s): Steering arms inside the transom on top of the rudders and connected with a tie rod between the two rudders
 Rudder stock(s): Visually sound
