R J Whitfield & Associates, Inc.

CONFIDENTIAL REPORT OF CONDITION AND VALUATION SURVEY for purposes of pre-purchase evaluation

Survey #10/16-XXXX
C & C 110
Survey performed for XXXX, purchaser,
with the vessel hauled out,
on 10/21/16

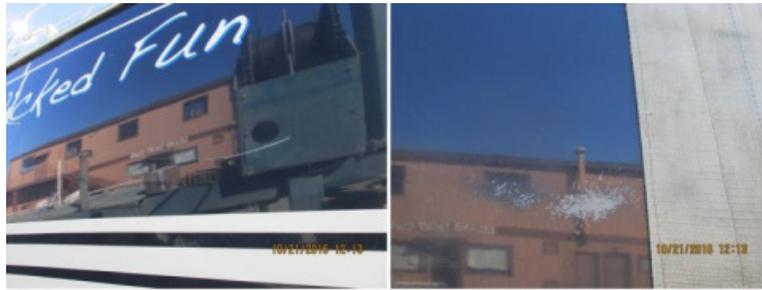
Construction material: Fiberglass
Stem: Flared
Rub rail: Molded plastic with insert
Transom: Reverse transom
Transom storage: Transom compartment opens to serve as a step to the cockpit -- hinged boarding ladder stored inside the compartment
Hull cosmetics: Scrape in hull surface, port aft quarter, and surface abrasion just aft of port beam; minor chips out of the edges of the cove stripe, both port and starboard sides.

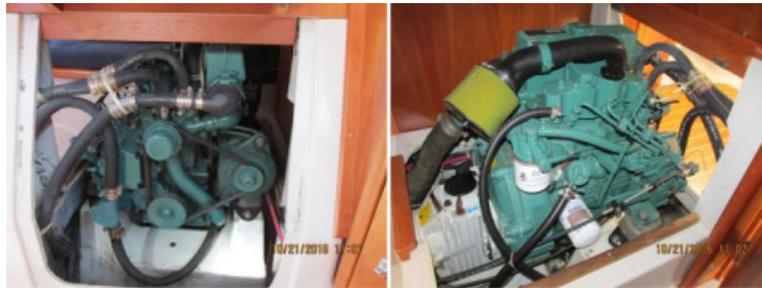
Type: Inboard engine with sail drive
Manufactured by: Volvo Penta
Serial number(s): 5102127689
Model number(s): MD2030-C BT
Naturally aspirated? Yes
Horsepower: 28 HP (reportedly)
Number of cylinders: Three
Year: Unknown
Engine(s) location(s): Aft of companionway
Engine space hatch(es): Beneath companionway steps and in aft cabin
Fuel type: Diesel
Fuel pump(s): Engine mounted
Fuel filter(s): Volvo Penta 861477-8
Hoses and clamps: Good
Belts and pulleys: Good
Engine mounts and beds: Good
Throttle and shift control(s): Single lever
Alternator(s) approved type: Yes
Drip pan(s) beneath engine(s): Oil absorb pad
Cooling system(s): Heat exchanger cooled
Oil level and condition: Oil is dirty -- *recommend oil change.*
Oil filter(s): Volvo Penta 3581621
Ventilation: Natural
Insulation: Hatch and cover fully insulated
Engine alarm(s): High water temperature and engine oil pressure alarms installed.
Accessibility: Very good

Last major overhaul: Unknown -- reportedly serviced in 2014
Engine(s) operated: Engine not operated for purposes of this survey but the vessel came to the yard under her own power.

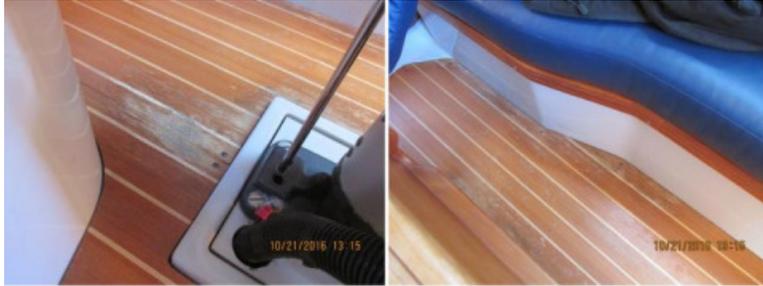
Curtains: No
 Heating/Air conditioning: Portable 110V heater
 Smoke detector(s): No -- all vessels 26 feet or more in length, with accommodation spaces intended for sleeping, shall be equipped with a single station smoke alarm -- *provide a minimum of one smoke alarm (per NFPA 302-44.12.3).*
 Carbon monoxide detector(s): No -- *provide a minimum of one marine grade (equipped with a self-wiping sensor) carbon monoxide detector.*
 Flammable(s) stored inside cabin: None sighted
 Cabin fans: Yes -- 12V
 Cabin lamp(s): Operation of the starboard 12V cabin light in the V-berth is intermittent -- *correct, as required.*
 Flooring: Teak & holley cabin sole installed in the main saloon -- water and wear stains noted.

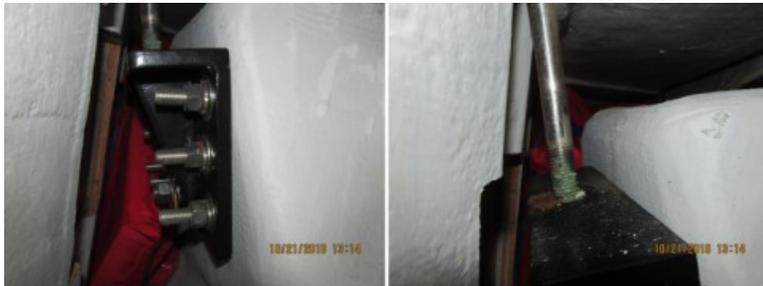
Upholstery: In very good condition
Condition: Interior is in well kept condition, aside from the aforementioned flooring.
Window leakage?: No evidence sighted.
Chain plates: The chain plates are attached to the internal bulkheads and are readily available for inspection.
Chain plate(s) leakage?: No evidence sighted, although some discoloration of the tie rod and the bolts noted -- *monitor and correct if conditions worsen.*

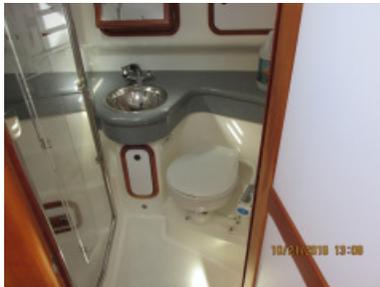
Toilet(s): Jabsco manual
Type(s) of marine sanitation device(s): Type III -- when operating this vessel on a body of water where the discharge of untreated sewage is prohibited by the EPA under 40 CFR 140.3, the operator must secure each Type III device in a manner which prevents discharge of sewage -- see Holding Tank section.
Shower(s): Handheld in stall -- pin missing from one of the cupboard hinges in the stall -- *correct, as required.*
